# Monitoring Runoff Water Quality around the Science Learning Center

## INTRODUCTION:

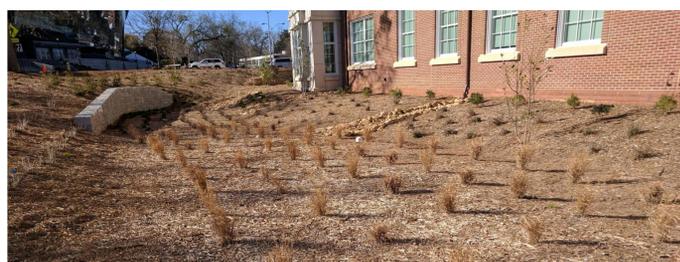
Figure 2. Rain garden next to the Science Learning Center

In the SLC rain gardens, surface substrates (rocks, mulch, and vegetation) discourage sediment erosion, and deeper substrates filter sediments out of draining water. In traditional lawn areas, the soil tends to be highly compacted, causing water to enter surface drains with little to no filtration.
