The Impacts of Sustainable Grounds Design on Water Infiltration Rates

Contrast soil infiltration rates between three sites with varying levels of sustainable design around the Science Learning Center

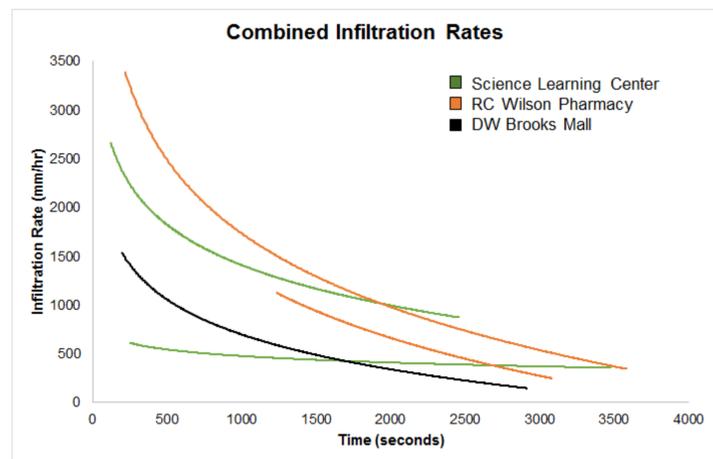
Figure 1. Infiltration rate (mm/hr) over time at the SLC (n=2), RC Wilson Pharmacy (n=2), and DW Brooks Mall (n=1) is fit to a logarithmic curve.

Dry soil can absorb a large amount of water initially, then the infiltration rate declines as the soil becomes saturated. This infiltration curve reflects the rate of water absorption over time, and it eventually reaches a steady state.

The SLC had the highest steady state infiltration rate, followed by the pharmacy, then the lawn.

Steady state infiltration rates around the SLC were higher than for the pharmacy or lawn. The sustainable landscape design around the SLC may be the cause of its high infiltration rate.

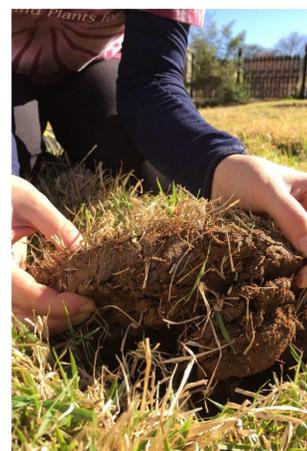
Figure 2. Compacted soil and turf grass on the DW Brooks Mall.

The turf grass lawn was too compacted to measure, suggesting that these lawns have a very low infiltration rate. Our infiltration measurement for lawn sparse in grass also showed that the steady state infiltration rate for the lawn was low.

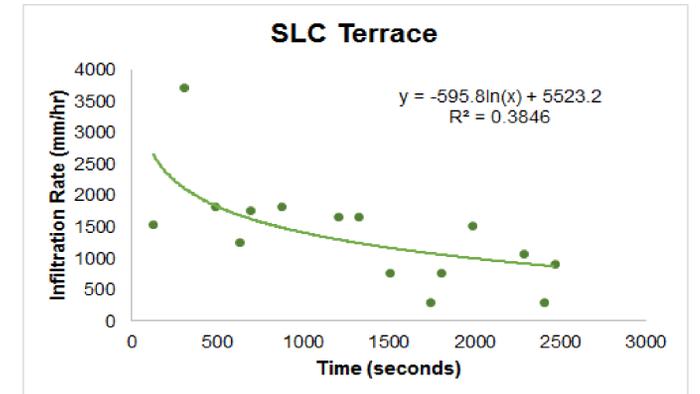
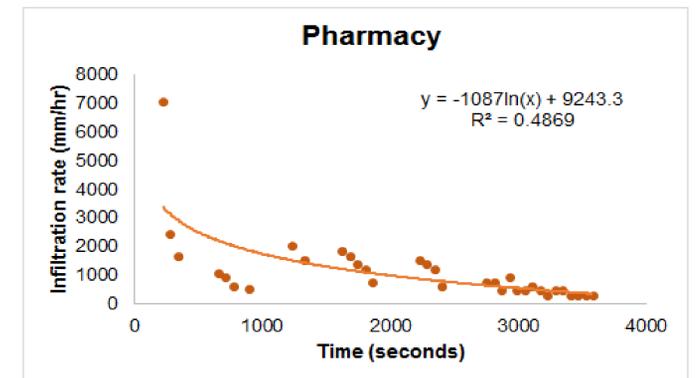
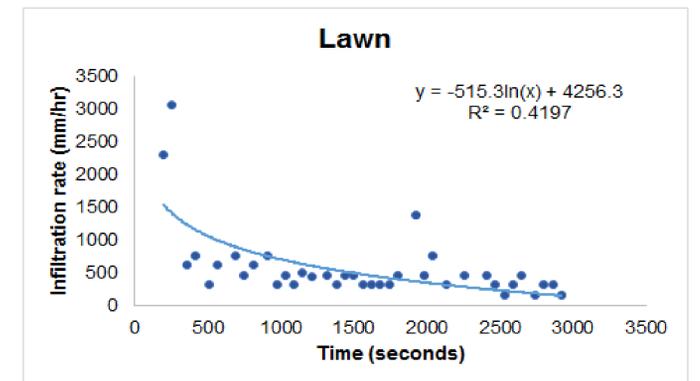
Infiltration Rates for SLC, Pharmacy, and Lawn Sites

Figure 3. Infiltration rate data for one SLC, pharmacy, and lawn site fit with a logarithmic curve. Curve equation and R² is displayed.

One limitation of this study is the length of infiltration measurements - we took data for up to an hour, but most of our curves did not reach their absolute steady state infiltration rates. We are also limited by sample size, so we are unable to compare mean infiltration rates or variances. Because this study is still in progress, we will be able to make more robust conclusions in the future.
